Independent Engineering Report

Aguirre Power Plant Complex

Report SL-015976.AG

September 24, 2021

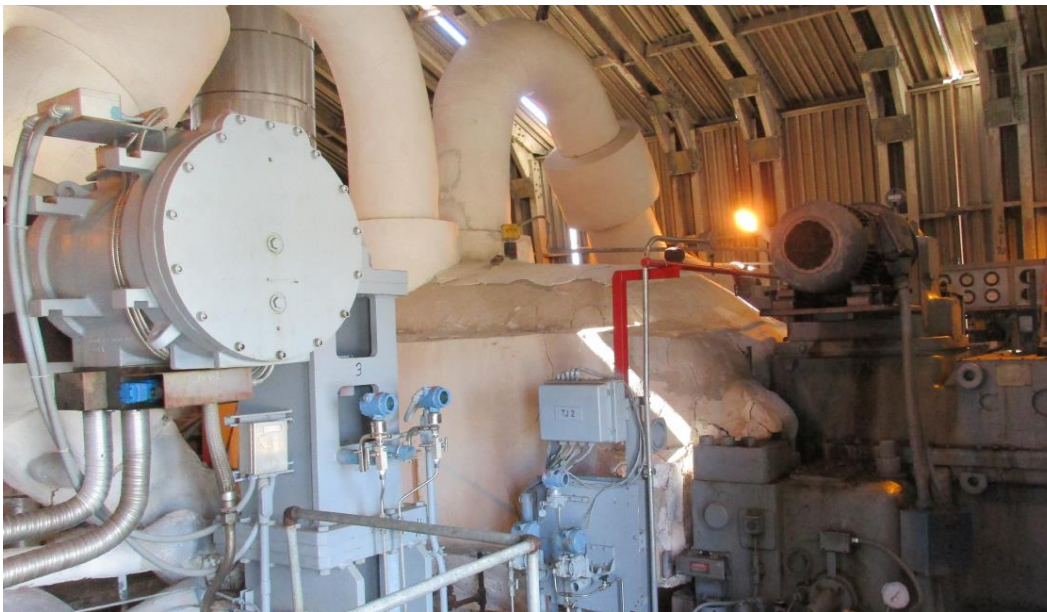
Figure 3-1 — Unit 1 STG HP Section with Turning Gear

The overall appearance of the Unit 1 STG is acceptable given the age and location near a coastal area. Figure 3-1 is generally representative of the entire machine's condition. Note that some doors were found

open or non-functional. This is a concern if the fire protection system needs to be activated. The HP and IP rotors have around 43,000 operating hours since they were replaced in 2012, and they are due for a 50,000-hour major inspection. The LP rotors are overdue for inspection, with approximately 65,000 operating hours since they were replaced at the end of 2008. No inspection has been scheduled at this time; however, the Plant recently received refurbished spare HP and IP rotors, and a project to requalify the spare LP rotors on site is pending. Quotes have been solicited for the project of interchanging these with the aging Unit 1 STG rotors.

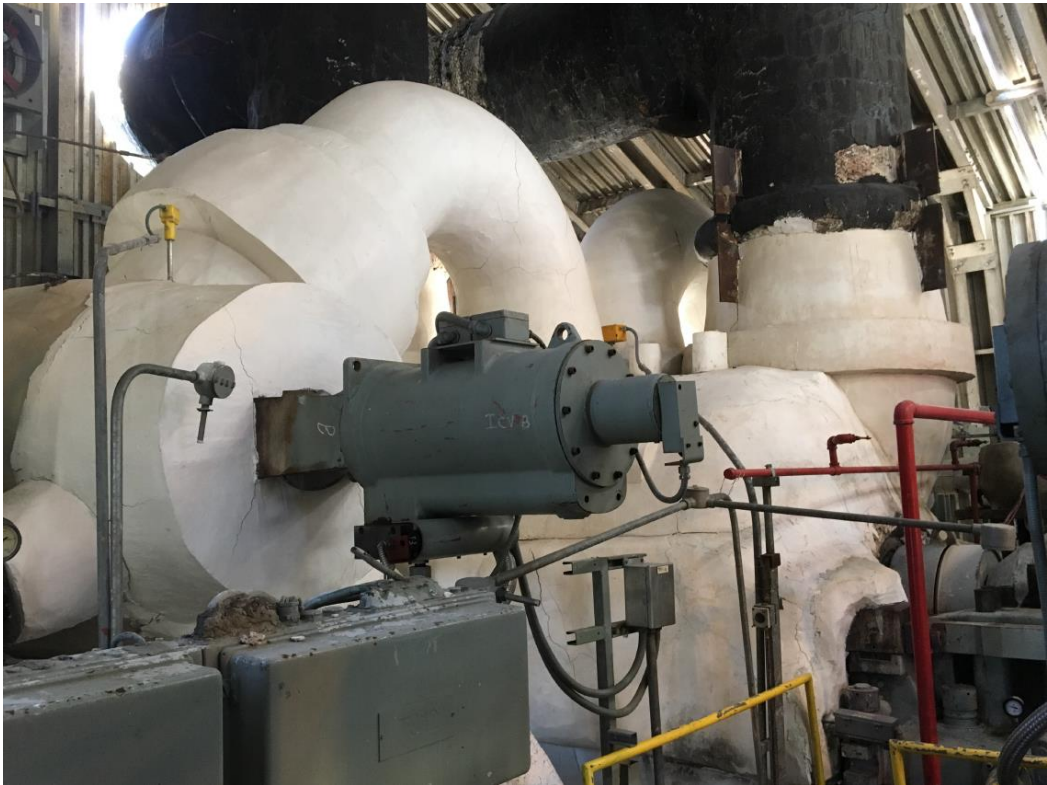
Figure 3-3 — Unit 2 STG IP Section

The overall appearance of the Unit 2 STG is acceptable given the age and location near the sea. Note that some doors were found open or non-functional. This is a concern for fire protection if the fire protection system needs to be activated. The Plant's spare HP and IP rotors were installed in 2017 and have since logged about 9000 operating hours. The LP rotors have 50,000 operating hours and were due for a major inspection in 2019. Figure 3-3 is representative of the ST's condition.

The cross-over piping to the LP section is seen above with black insulation.
The HP section is on the right (not shown in photo).

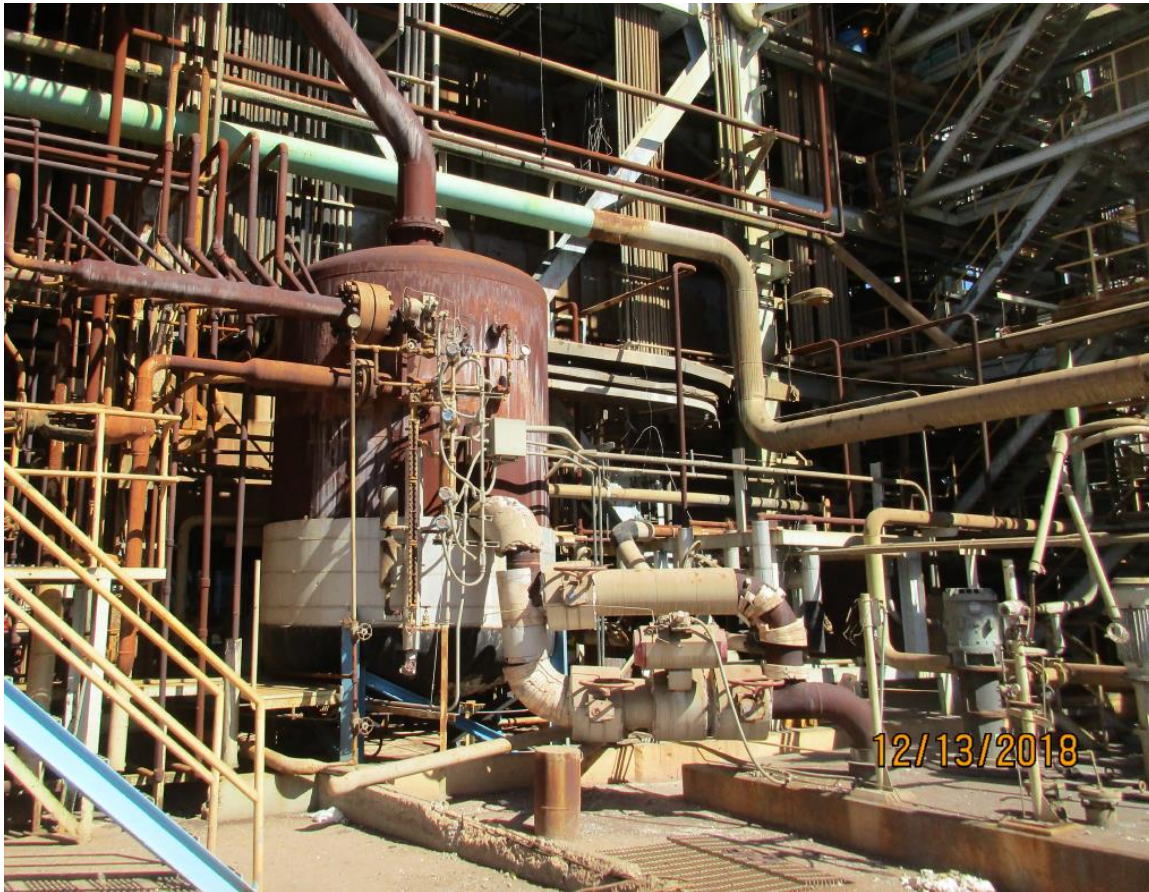
Figure 3-5 — Unit 2 Boiler Blowdown Tank

The boiler blowdown system is working well, even though the tank and many of the drain lines are uninsulated and corroded; however, tank internal erosion and blowout is a concern at this stage of the Plant life. See Figure 3-5.

The tank drains to the sump on right, from which the water is pumped to the raw water tank for reprocessing as demineralized water.

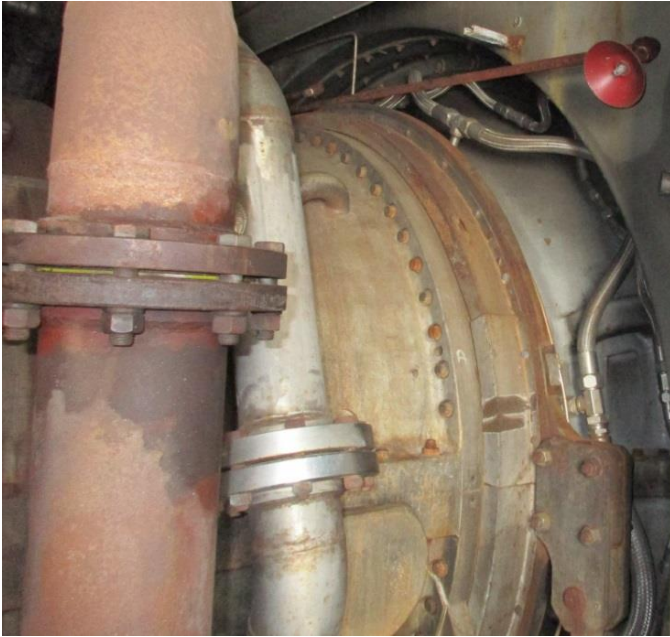
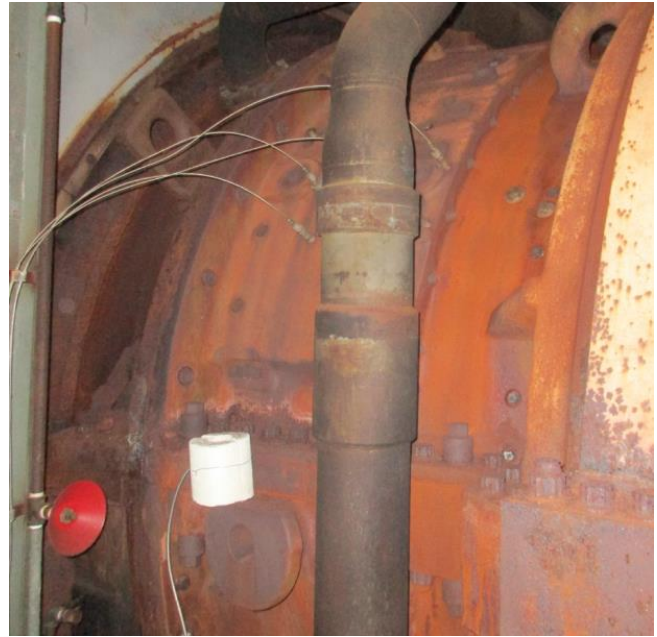
Figure 3-6 — Combined-Cycle GT Casings

Due to extensive corrosion, the GT enclosures are generally in poor condition, the GT casings are in good-to-moderate condition, and the GT auxiliary equipment is in moderate condition. See Figure 3-6 through Figure 3-8 for examples. Note that a new GT rotor was installed in GT 1-3 in 2003 and that GT 2-2 has recently been reassembled after being disassembled for repairs.

GT1-4 compressor casing

GT1-4 combustors

The effectiveness of the CO₂ fire suppression systems for the GTs is questionable because the turbine and auxiliary enclosures are corroded with damaged or missing seals across all enclosures; this makes them unlikely to hold suppressant per NFPA requirements.

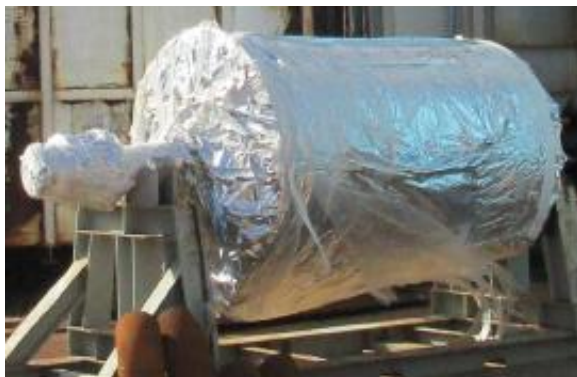
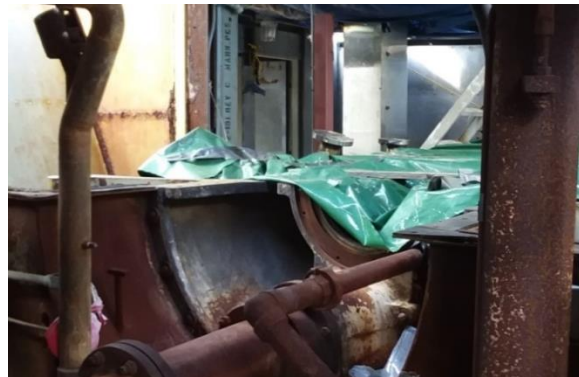
Figure 3-8 — GT 2-2 Compressor Rotor Storage and GT Housing Layup

GT 2-2 has recently been reassembled after being disassembled since 2016. Over that period the GT 2-2 rotor was sent to the mainland United States for repairs, but it was poorly protected during the return shipment, rejected on site, and sent back for remediation. The rotor returned to site again in the spring of 2019, and the unit is in the final stages of reassembly. Figure 3-8 shows the lower half of the GT 2-2 housing as it was stored during this period, partially tarped in the GT enclosure.

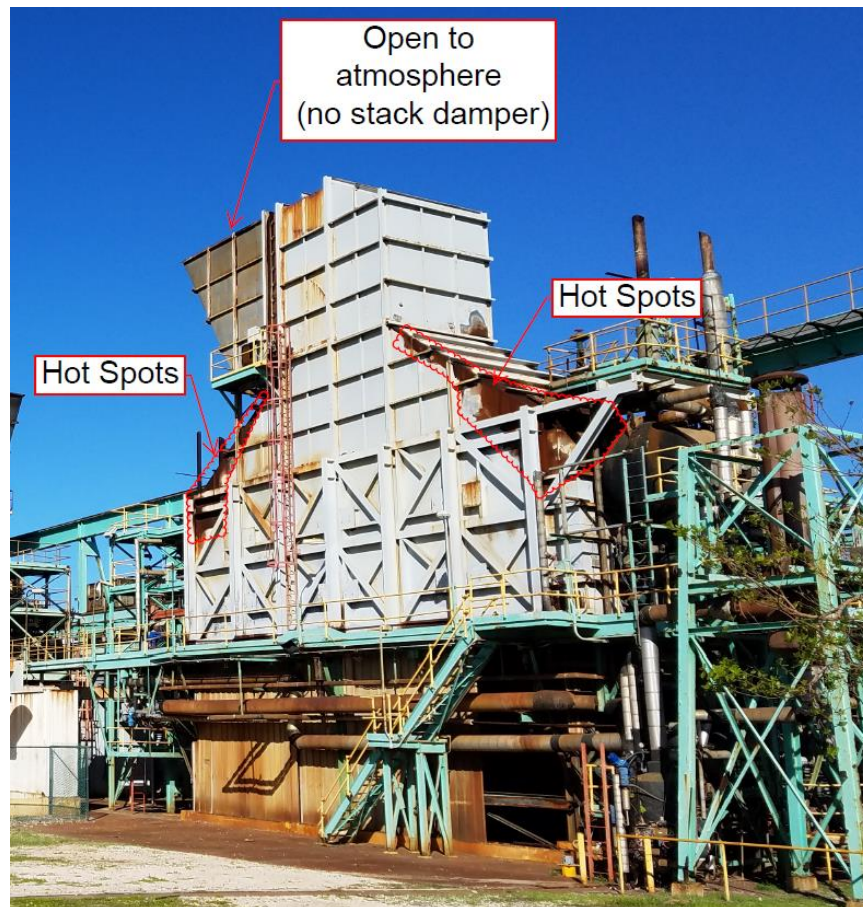
Figure 3-9 — STAG 2 HRSG 2-4

Major pressure part components of the GE HRSGs, including superheater, evaporator, and economizer modules at the CC plant, were replaced by Senior Engineering in 1994 and 1995. From visual inspection, the HRSG casings are in poor condition, and obvious hot spots were noted, as shown in Figure 3-9. Electrical junction boxes were moved away from the middle of the HRSGs to avoid damage from flue-gas leaks.

thermal performance when in operation. Installing stack dampers will help minimize corrosion and can shorten startup durations depending on the amount of time between starts.

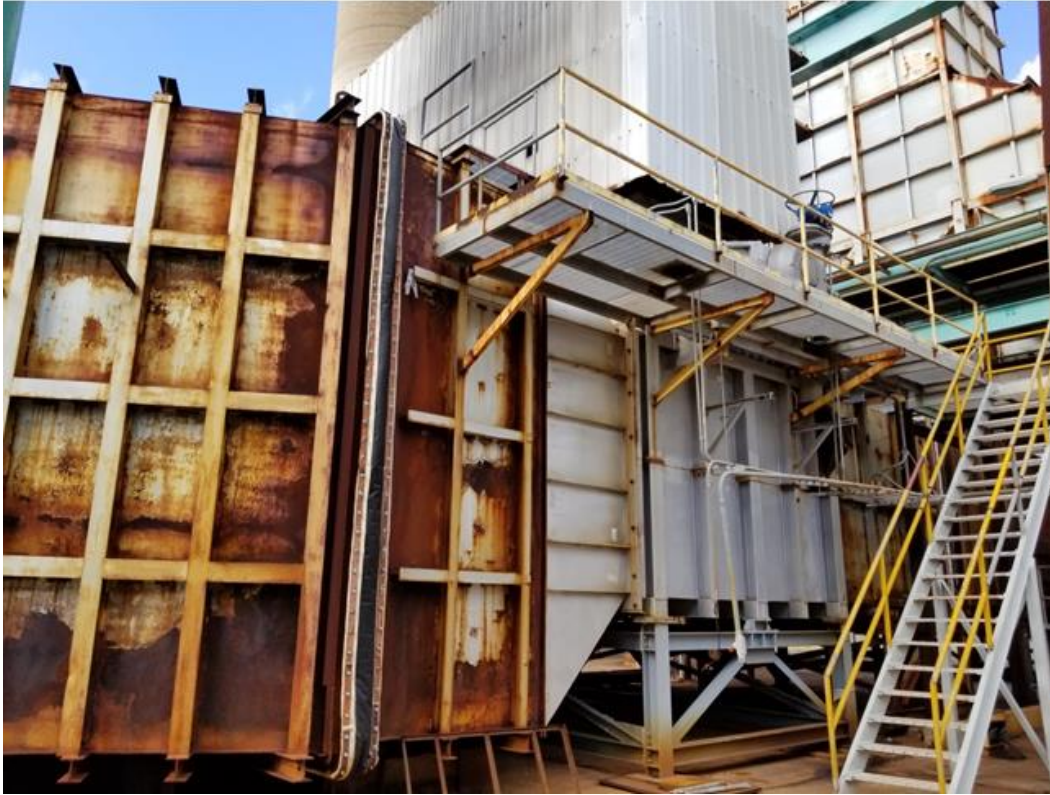
Figure 3-11 — GT Discharge Duct Diverter Damper and Stack

The diverter dampers are in good condition and work well (see Figure 3-11). The mechanisms are exercised when not in use to keep them in a ready condition. Though the appearance of the adjacent duct is poor, maintenance is performed to ensure operability as indicated, with a recent replacement of the expansion joint shown.

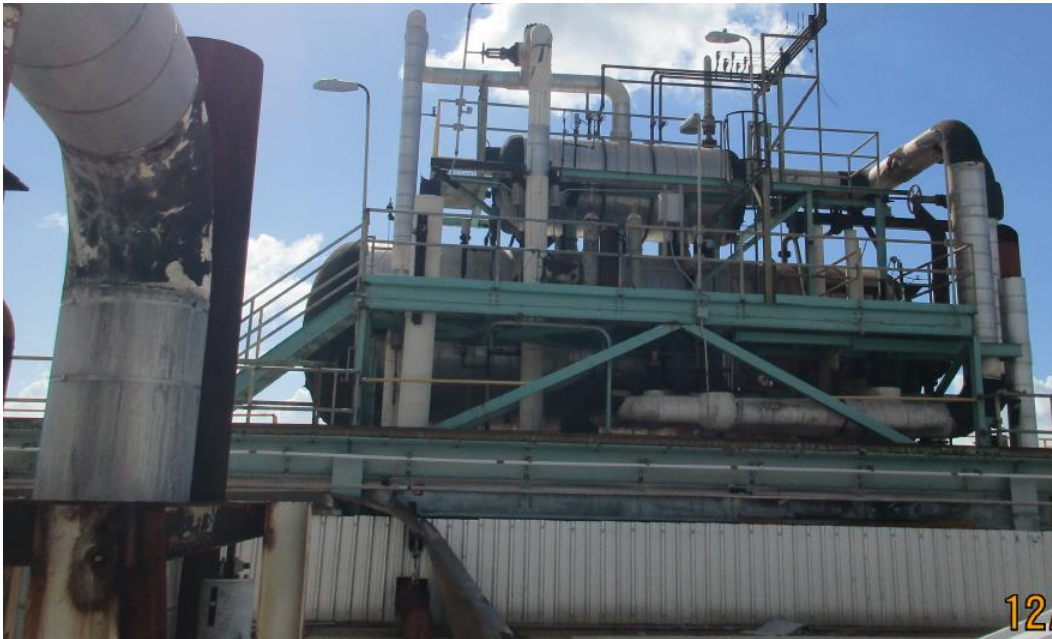
Figure 3-13 — Combined-Cycle Deaerator

On the roof of the control room building is the deaerators for both units. The STAG 1 deaerator, shown in Figure 3-13, is in good visual condition. The STAG 2 deaerator is in a similar condition.

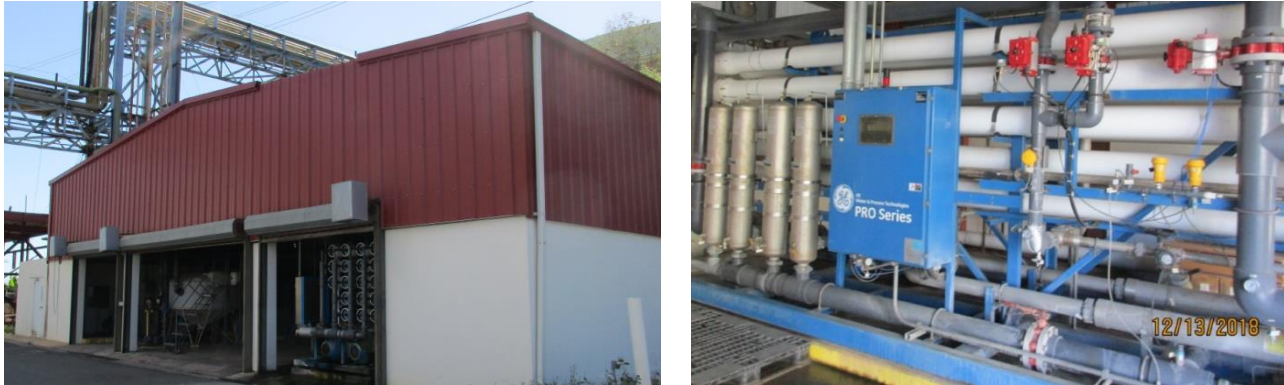
Figure 3-20 — Water Treatment Building

The mixed bed system is located in the water treatment building at the thermal units. It has two trains that can each produce 600 gallons per minute. The Plant typically needs 450 gallons per minute of demineralized water. The building and equipment are in good-to-moderate condition, as seen in Figure 3-20.

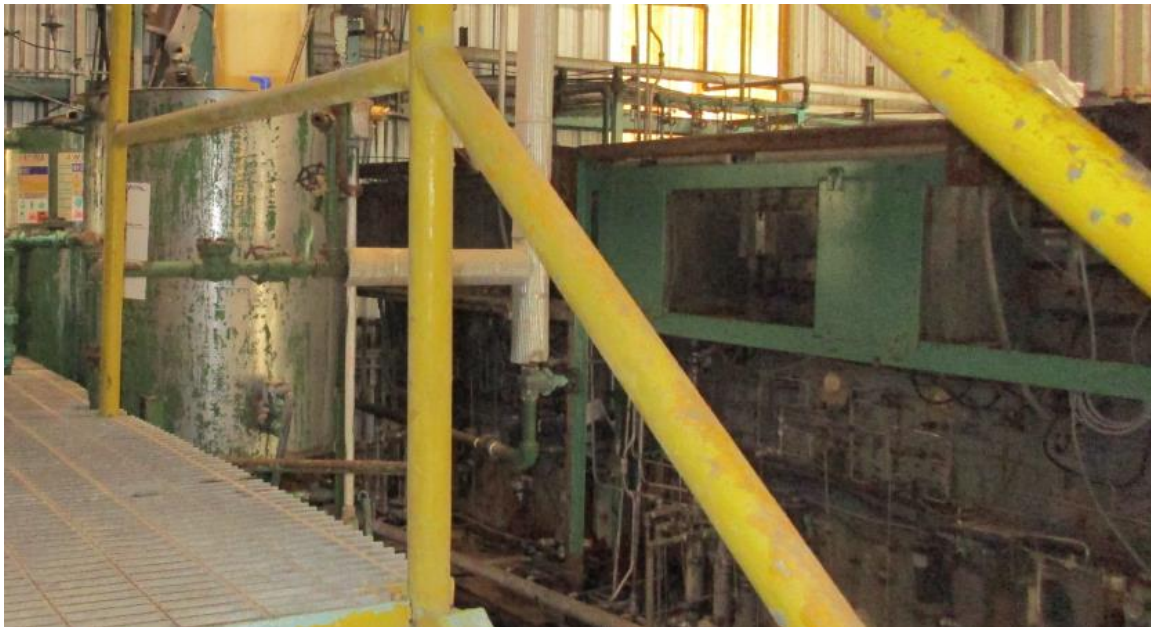
Figure 3-21 — Demineralizer at CC Unit

STAGs 1 and 2 have a demineralizer below their control room; see Figure 3-21. In 2008, it was decided to obtain process water for operations from the Aguirre thermal facility. Some of the CC demineralizer equipment is used to apply necessary chemicals into the demineralized water received from Aguirre. The STAG chemical feed system is nearing its end of life. The feed tanks, pumps, and other items are likely to require replacement in the near future.

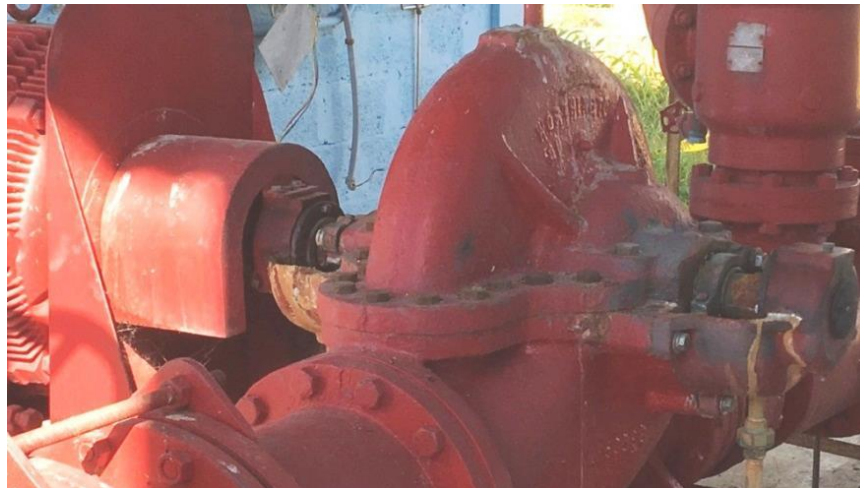
Figure 3-25 — Electrical-Fire Pump

The fire protection underground loop is leaking at an undetermined location. While pressure can be maintained in the fire system, it requires use of the jockey pump at all times, which is not a normal industry practice. Plant personnel plans to hire a contractor to locate the leak. Both diesel fire pumps and the motor-driven fire pump were replaced in 2013.

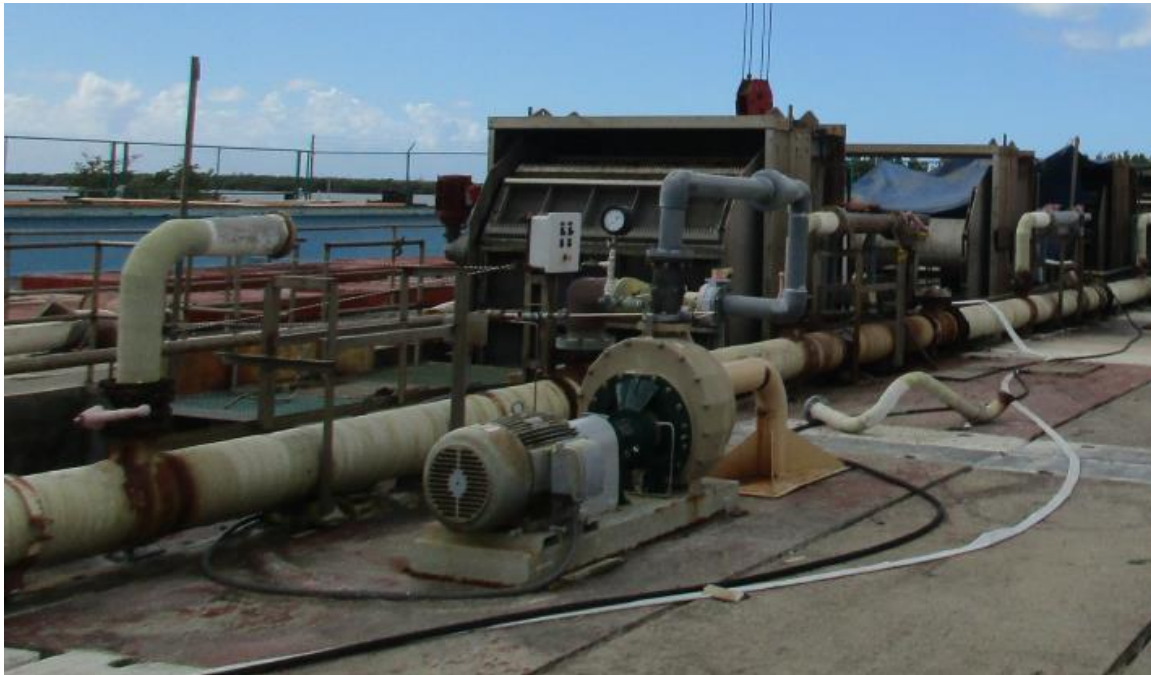
Figure 3-26 — Traveling Screens

There are five traveling screens, and PREPA plans to replace them for Clean Water Act Section 316(b) compliance. As of the end of 2020, two screens were out of service; Screen 3 was having corrective maintenance done on the deck, and Screen 1 had a major issue 3–4 years ago and has remained out of service. The concrete structure appears to be in good condition. A surface barrier was installed to keep seasonal sargassum seaweed from clogging the inlet screens. The Plant notes that there is an Engineering Department project currently underway to replace all five travelling screens with fine-mesh modified travelling water screens and a fish return system to bring them into compliance with Clean Water Act Section 316(b).

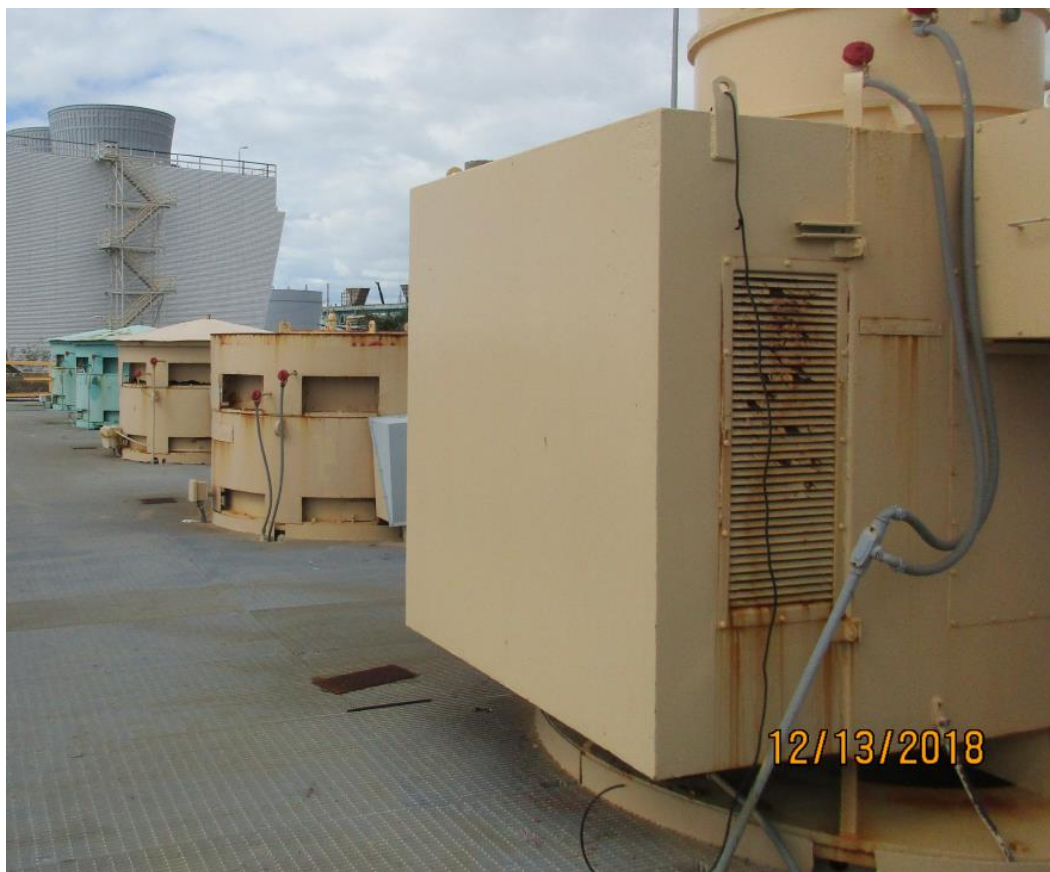
Figure 3-27 — Circulating Water Pumps

Following the traveling screens are five circulating water pumps for Aguirre Units 1 and 2. Two of the pumps serve Unit 1, two serve Unit 2, and one is a shared installed spare. Circulating water Pump 2-1 was refurbished in 2012.

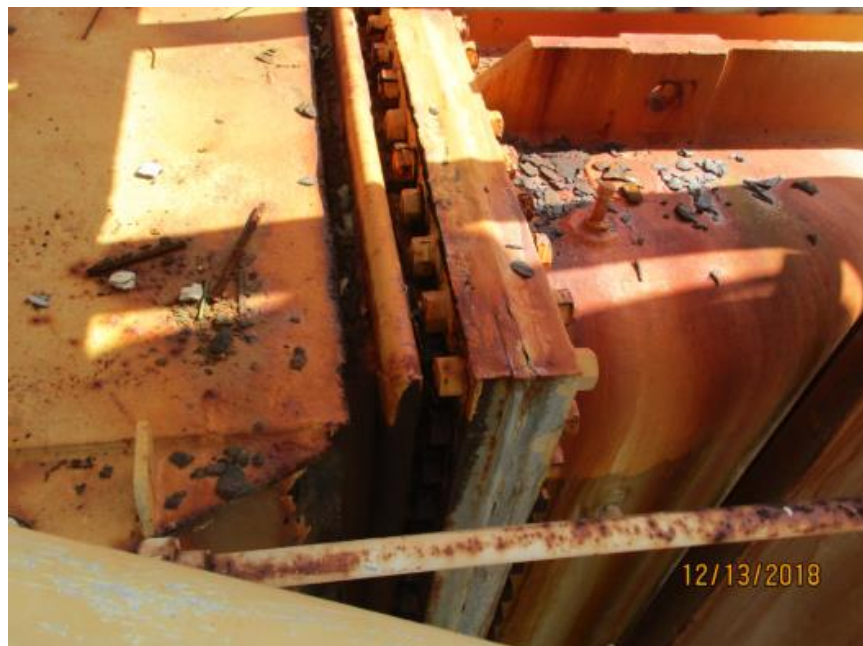
Figure 3-31 — Combined-Cycle STAG 1 Condenser

The CC is implementing a plan to improve the condenser vacuum by increasing flow from the cooling towers. This will especially help when they run all four GTs on a unit. Circulating water Pump 2-2 was recently retrofitted with a new impeller, and its motor was rewound to yield 2200 hp from 2000 hp. Plant personnel is correcting some minor deficiencies and plans to bring the pump back into service in the fall of 2020. Similar upgrades are planned for the other three circulating water pumps and motors. To also help with condenser performance, one waterbox from each of the two Unit 2 condensers was sent off site to be refurbished with application of a ceramic-based coating in 2019. The other two waterboxes received a similar scope of work with the work being done on site. The refurbishment of the waterboxes has been completed, and they will be returned to service with the refurbished circulating water Pump 2-2 in the fall of 2020.

One of the STAG 1 condensers with waterboxes coated on the inside in 2017.

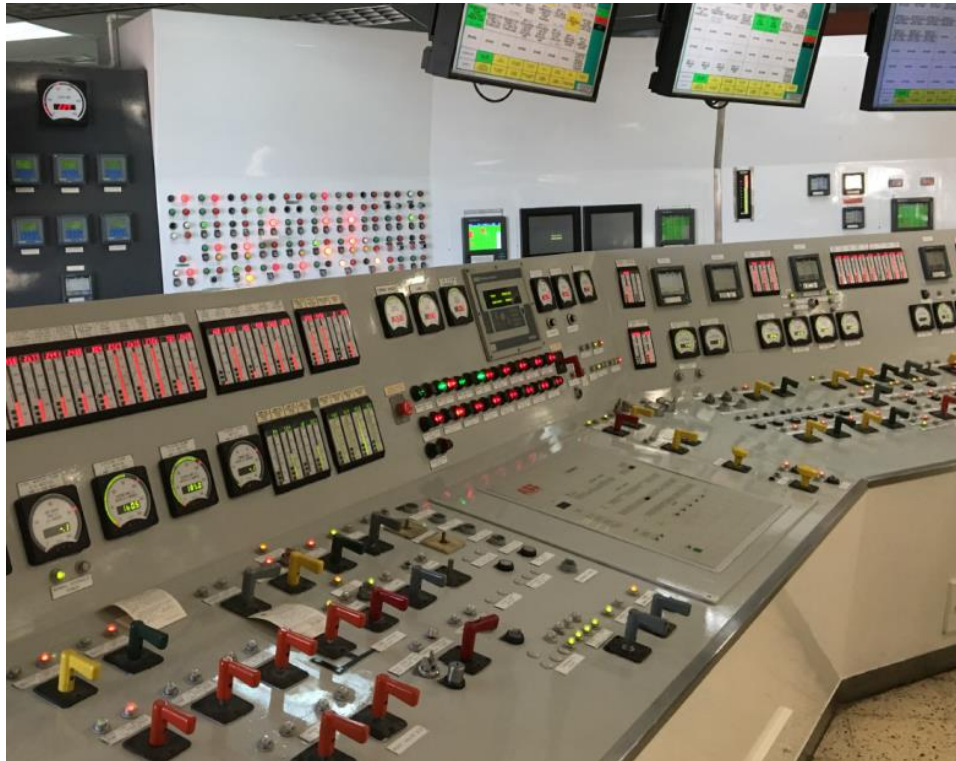
Figure 3-33 — Control Room Units 1-2

There is a common control room for Units 1 and 2 with separate controls for each unit. There is a similar arrangement for the CC units. The Plant uses Foxboro distributed control systems and has a contract agreement with Schneider Electric for maintenance of their boiler controls systems through August of 2021.

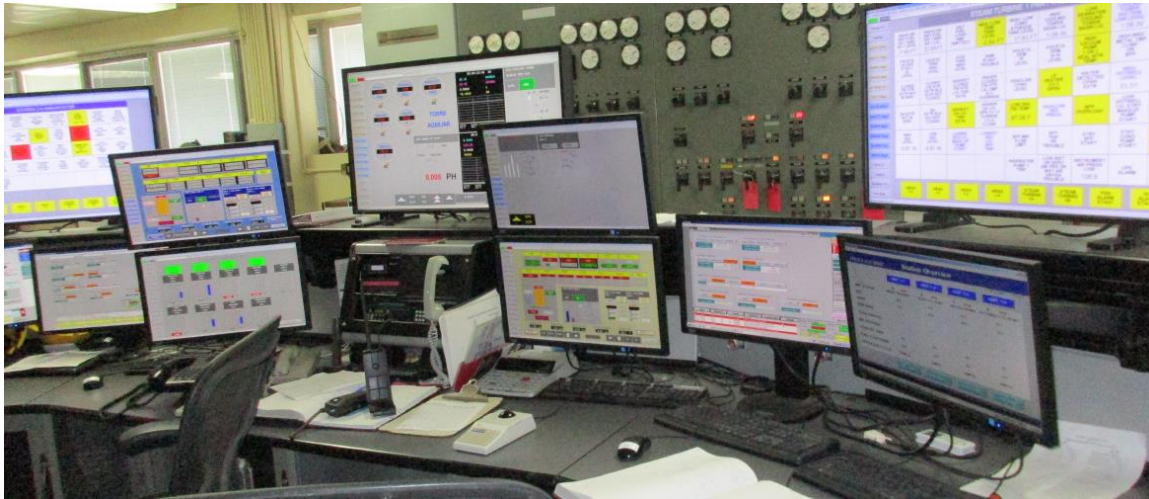
Figure 3-34 — HRSG Control Room – Foxboro Upgrade in Progress

The HRSG controls upgrade by Foxboro for both units was completed in February 2019. The STAG 1 STG controls were upgraded from Mark V to Mark VI-E, with the project completed on June 27, 2020. The Plant intends the same upgrade for STAG 2 and, as of the end of 2020, was in contract negotiations with Baker Hughes/Nexus Controls for this work for targeted completion by May of 2021. The GE Mark V controllers for all eight GTs will be upgraded to Mark VI-E, at which time new EX-2100 model exciters will also be installed. Each of the communications rooms for the eight GTs has a new door with a safety window.

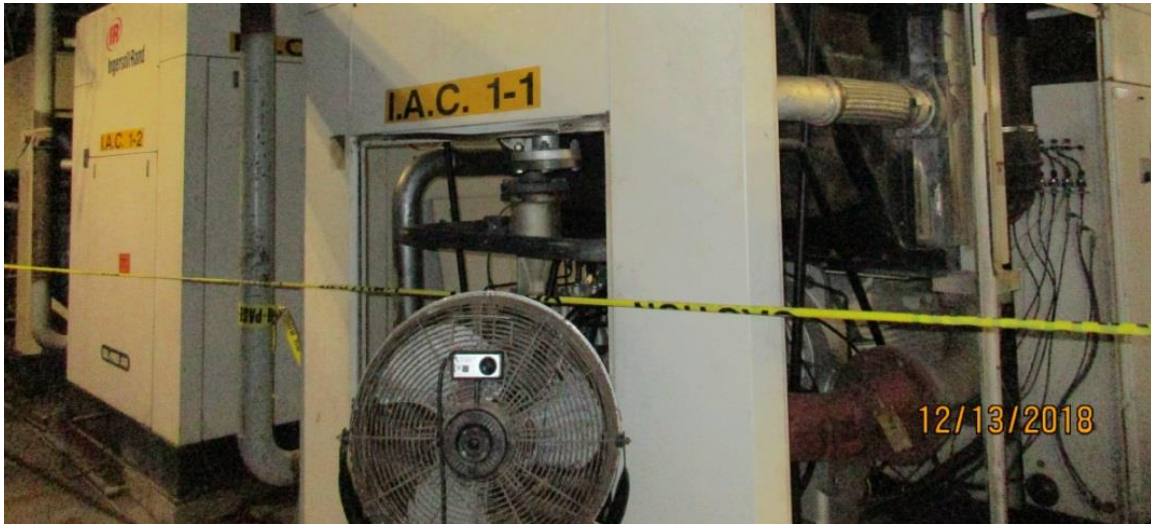
Figure 3-35 — Thermal Units Instrument Air Compressor

The instrument air compressors for both thermal units are in moderate-to-good visual condition, but there are issues with interstage cooling. Each unit has two 100%-capacity instrument air compressors, but all four are needed to meet demand. Instrument air dryer IAD 2-2 is out of service on maintenance, and the other three dryers remain in service. The air is conditioned adequately when all three of the remaining dryers are used. Each unit also has a full capacity service air compressor and dryer, and these pairs can be used to back up the instrument air system. The service air equipment is also in moderate-to-good visual condition. The plant staff notes that leaks in the instrument and service air systems have recently been addressed. Additional storage of instrument air is provided by three repurposed propane tanks adjacent to the Unit 1 HFO heating skid. New propane tanks were installed east of the plant for separation reasons. The CC compressed-air systems are working well.

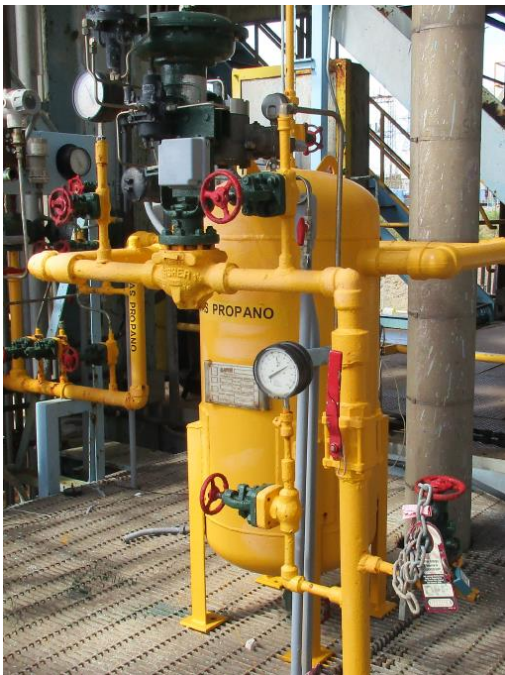
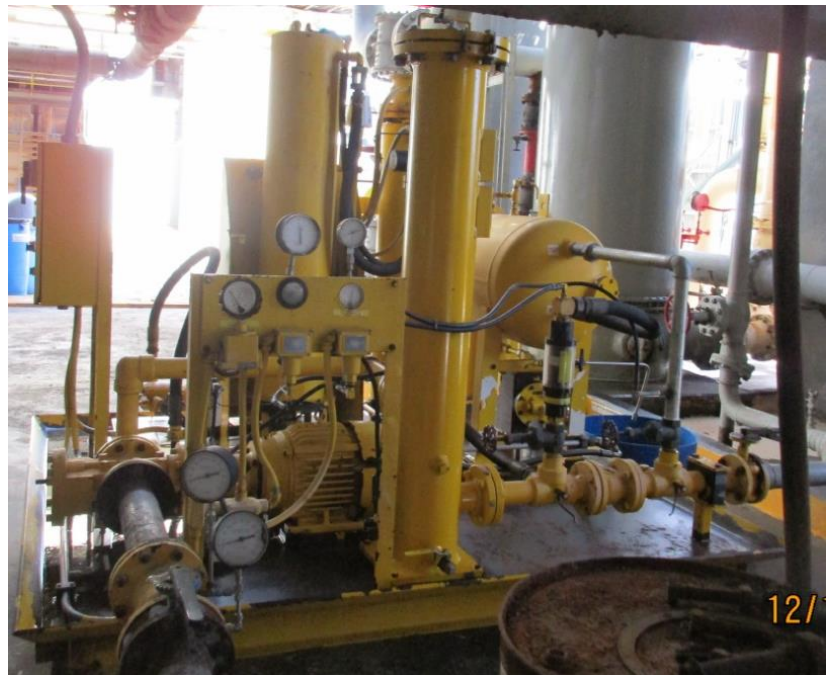
Figure 3-37 — Examples of Replacements/Re-Coatings, Units 1 and 2

Figure 3-37 and Figure 3-38 illustrate some of the corrosion issues and remedial activities recently performed for thermal Units 1 and 2. Besides the items pictured below, Sargent & Lundy also notes the recent replacement of the BFP recirculation valves and actuators as well as the Unit 1 FW heater isolation valves due to corrosion issues.

Unit 1 Propane tank, piping, and valves.

Unit 2 STG lube oil filtering skid.

- Accelerate mitigation efforts while corrosion mitigation efforts at the Plant are ongoing, especially at the CC facility. Some of the corrosion is decreasing unit output and reliability and some of it is a safety risk (as identified in Section 3.1.6.8).

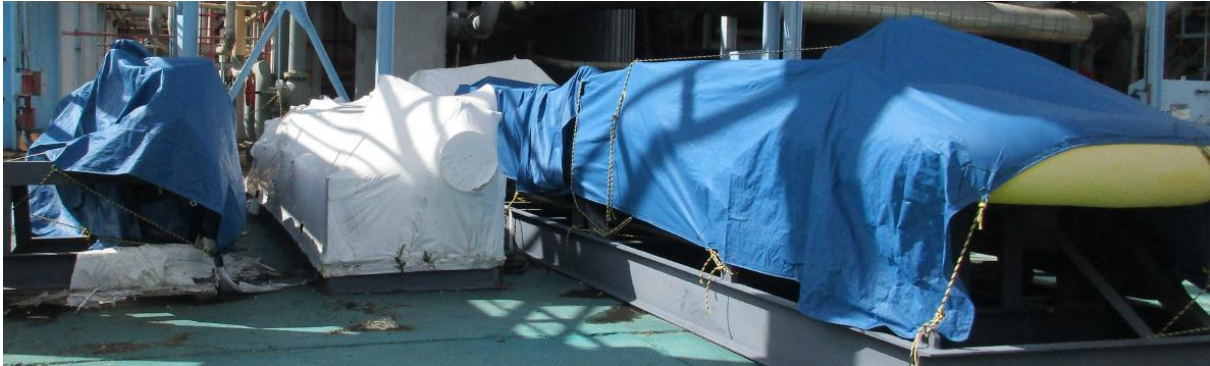
Figure 3-41 — Storage of Natural Gas Conversion Components for the Thermal Units

There are purchased modifications for the thermal units, and the gas conversion parts and fuel trains are currently being stored outdoors. The equipment appears in good condition, but a detailed assessment is recommended prior to putting any of the new equipment into service. According to the Puerto Rico Energy Board's (PREB) decision, no plans for natural gas delivery to Aguirre will be put into effect; however, there may be value in preserving the equipment for use at another PREPA facility that uses natural gas (e.g., Costa Sur) or for sale. Sargent & Lundy recommends long-term preservation, such as by relocating the equipment to indoor storage, for all purchased equipment for natural gas firing to preserve its value and functionality if an opportunity for reuse is identified. Figure 3-41 provides an example of the storage condition of the natural gas conversion components for the thermal units.

- Pursue long-term preservation for all purchased equipment for natural gas firing, such as relocating the equipment to indoor storage.
- Implement layup procedures for equipment and systems that include draining, dehumidifying, protecting, and, when needed, nitrogen-blanketing.
- Conduct a water study to be sure a temporary source of process water will not be needed before the Patillas Lake water is delivered. Monitor the progress of the Patillas Lake project and expedite the process as needed.
- Install HRSG stack dampers.
- Upgrade the protection of components being stored outdoors (in addition to the natural gas components).
- Implement a database to allow documentation to be more easily located and distributed. Many of the CC unit maintenance records were not provided for review because they are difficult to track and retrieve.

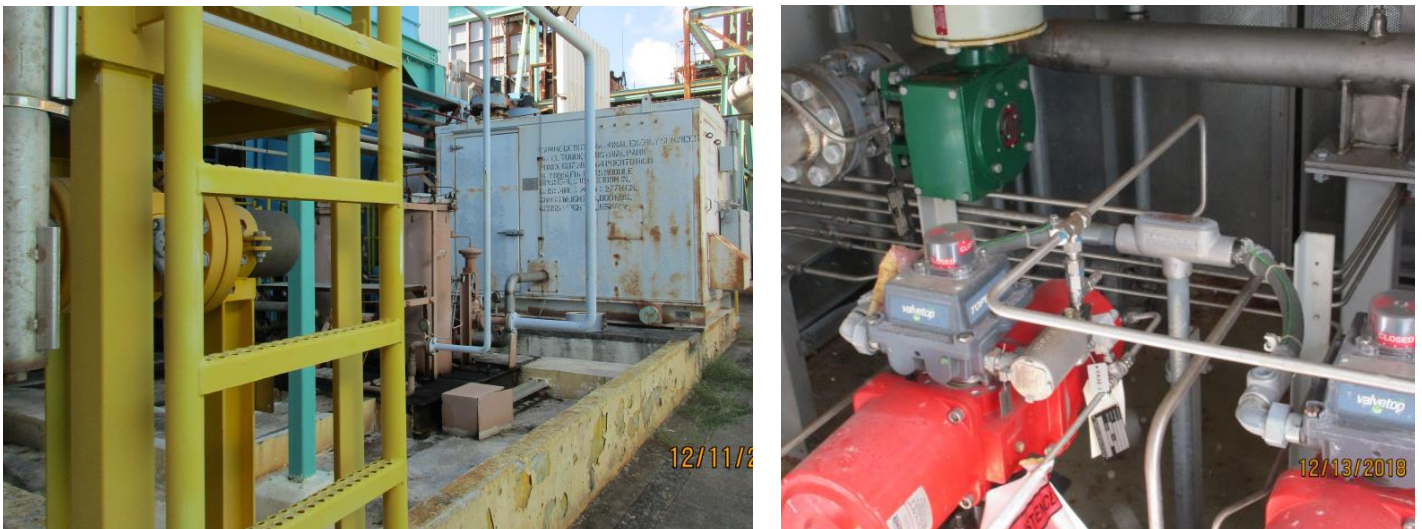
Figure 3-42 — Natural Gas Delivery Components Installed at CC Units

Similar to the thermal units, operation on natural gas would extend the life of the STAG units but is no longer being considered for Aguirre. The components are installed and in good visual condition, and the final filter skid and control valve enclosure are typical for each GT. They are seen in Figure 3-42.

The natural gas final filter is shown on the left (yellow); on the right is the gas control valve station inside the grey enclosure.

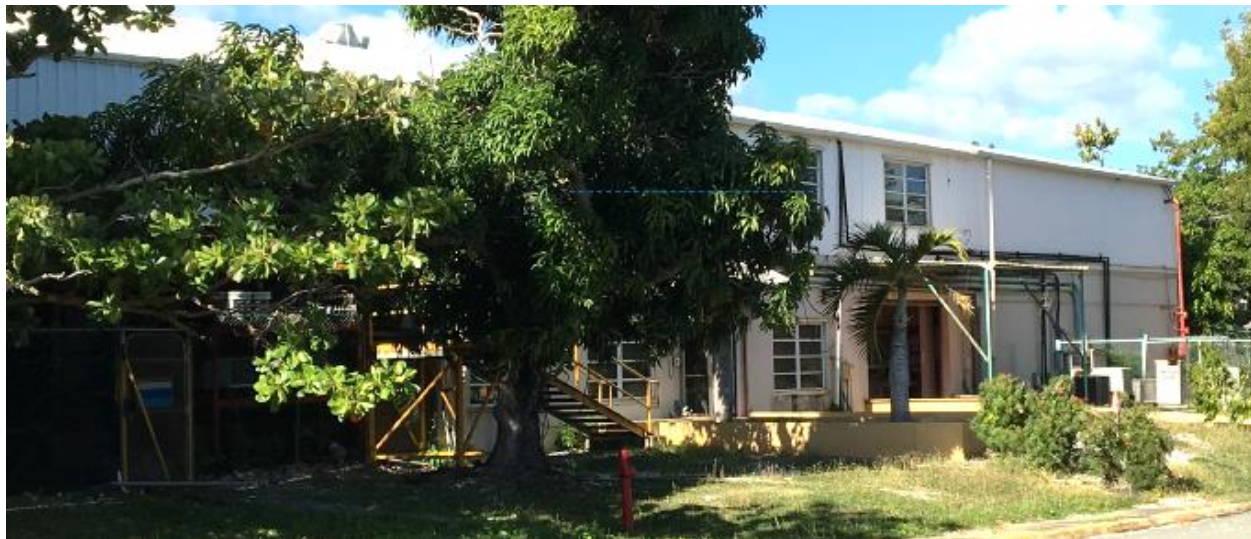
Figure 5-1 — Warehouse

A spares list for the thermal units was provided by PREPA, and it identified a multitude of small parts as well as air heater baskets, generator rotor, pump impellers, and capital valves. Tracking for local spares is done by hand and through the corporate asset management program.

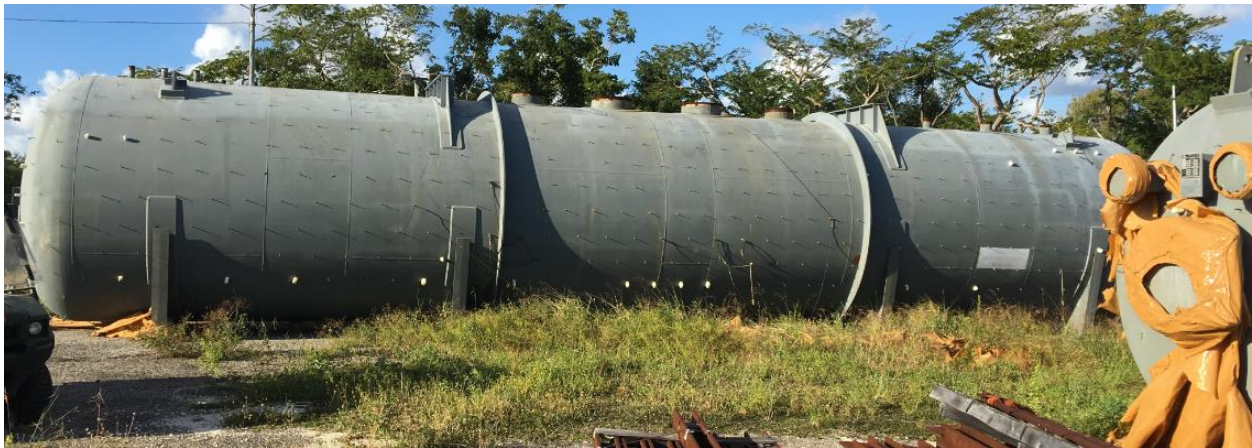
Figure 5-2 — Replacement DA and DA Storage Tank

A spare ID fan rotor and a spare FD fan rotor are on site. In the laydown yard with the boiler natural gas conversion parts is a replacement deaerator (DA) and DA storage tank. There is significant expense associated with installing the replacement DA due to access issues. The replacement DA and DA storage tank are uncovered but appear to be in good condition. During the 2019 site visit, Sargent & Lundy noted that the bearing journals of the FD rotors appeared to be well-protected, but other areas of the fan shaft should be cleaned and better protected. Plant staff reports that this cleaning was performed, and better protection has been provided.

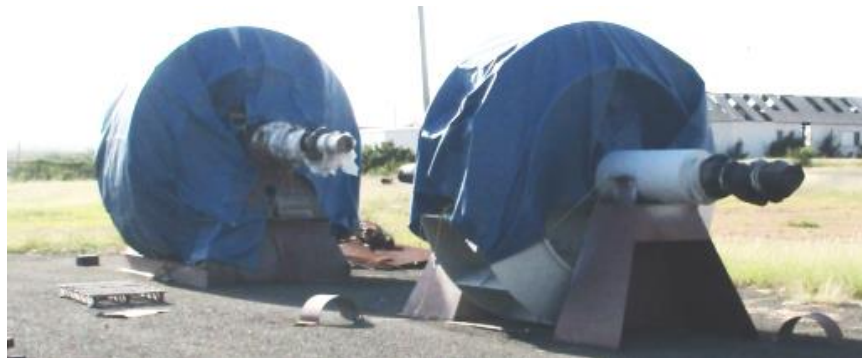
Figure 5-3 — Spare ID and FD Rotors

Outdoor storage—the bearing journals appear to be well-protected.

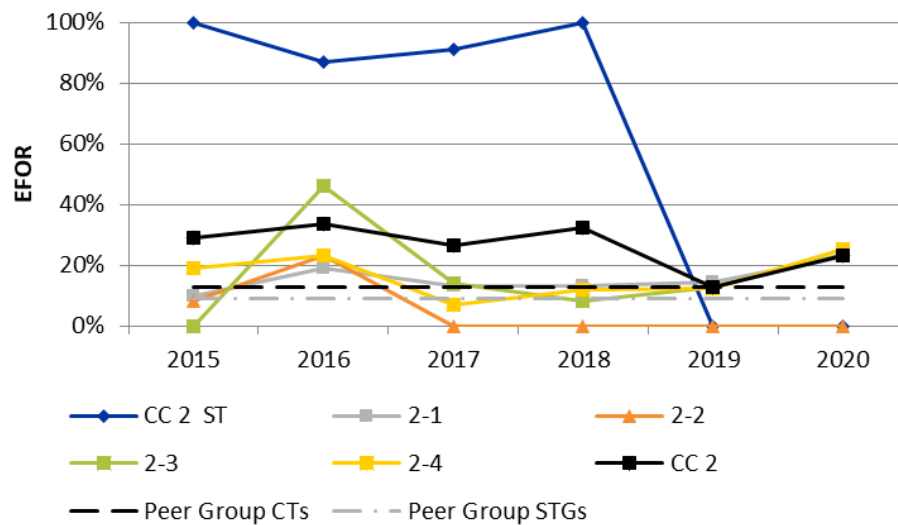
Figure 6-10 — Aguirre STAG 2 Equivalent Forced Outage Rate

Figure 6-6 and Figure 6-10 for the STAG 2 STG also show a discrepancy in the PREPA data in 2016 and 2017 with approximately 40% availability but an approximately 90% forced outage rate. Sargent & Lundy recommends PREPA revisit the inputs and calculations. The average STAG 2 (total) EAF has been decreasing from around 50% to 40% within the last five years.

Figure 6-9 and Figure 6-10 show the GTs with relatively low forced outage rates (similar to the peer group) and the STGs with high forced outage rates. The maintenance and planned outage factors (not shown) are also low for the GTs, except for GT 2-2, which has been undergoing a major inspection as discussed in Section 3.1.4.2; however, STGs have experienced several outages, as discussed in Section 3.1.4.5. The Aguirre EFOR for STAGs 1 and 2 is provided in Figure 6-9 and Figure 6-10, respectively.

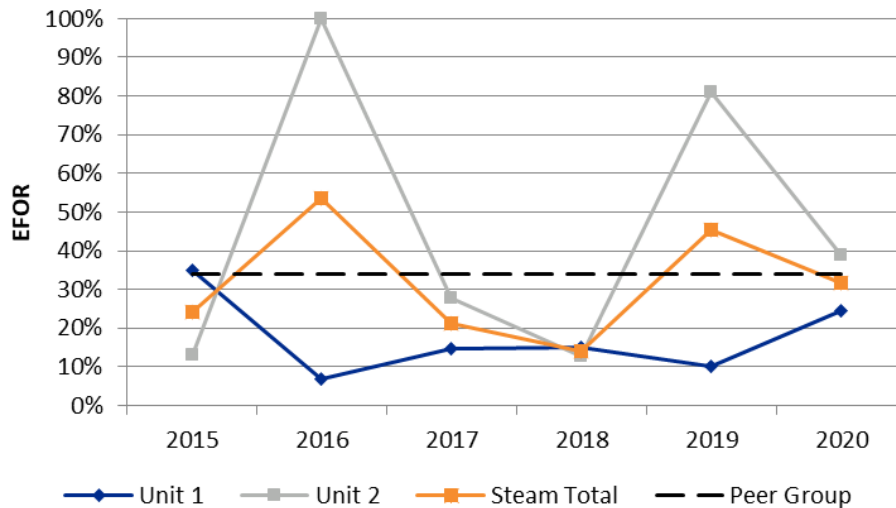
Figure 6-11 — Aguirre Thermal Plant Equivalent Forced Outage Rate

For the thermal units, Figure 6-11 shows an elevated (35%) Unit 1 EFOR in 2015, which is a result of the generator replacement at the end of 2015. Unit 2 was addressing extended STG issues in 2016 and underwent a major outage in 2019, which is also reflected in Figure 6-11. Unit 1 has generally had lower (better) EFORs than the peer group while Unit 2 has experienced higher EFORs than the peer group in 2016 and 2019, as noted above.

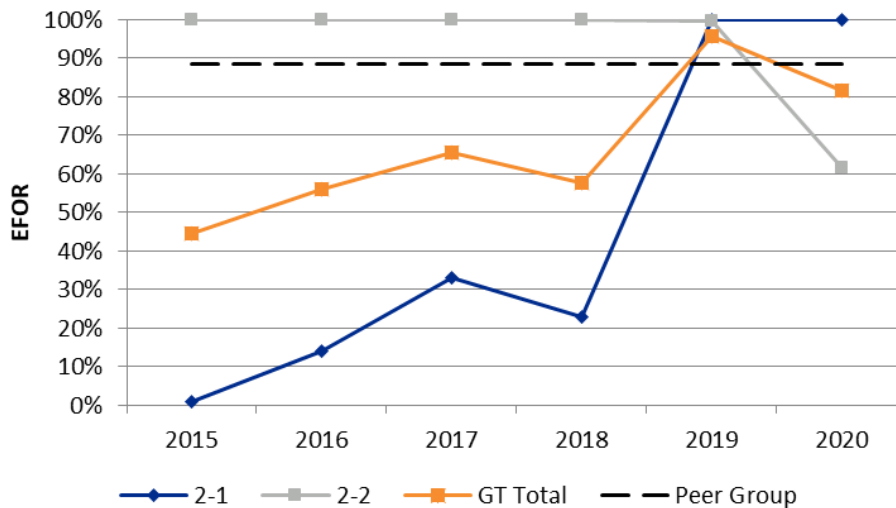
Figure 6-12 — Aguirre GT Units Equivalent Forced Outage Rate

The black-start GTs generally have had lower EFORs than their peer group; however, as noted previously, GT 2-1 has been out of service since it went into an outage for a combustor inspection in mid-January 2019, and GT 2-2 has limited use due to high oil temperatures.

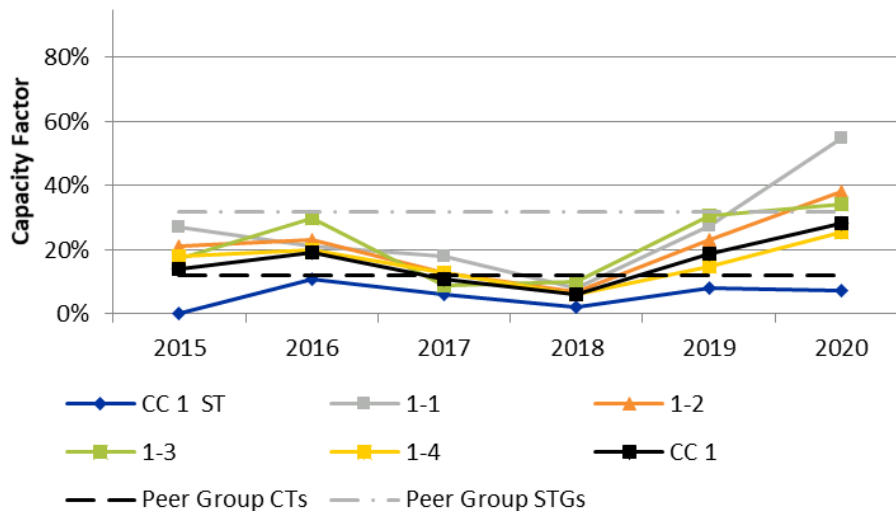
Figure 6-13 — Aguirre CC Unit 1 Capacity Factor

The NCF of STAG 1 is shown in Figure 6-13. The 0% capacity factor and 0% availability for the STAG 1 STG in 2015 was due to an extended planned outage. The severe hurricane damage to the cooling towers explains why the STG capacity factor decreases in 2017 and 2018. The average NCF of the GT generators and STG is included in the plot; it ranges from a low of 6% in 2018 to a high of 33% in 2020. This is generally in line with similar units.

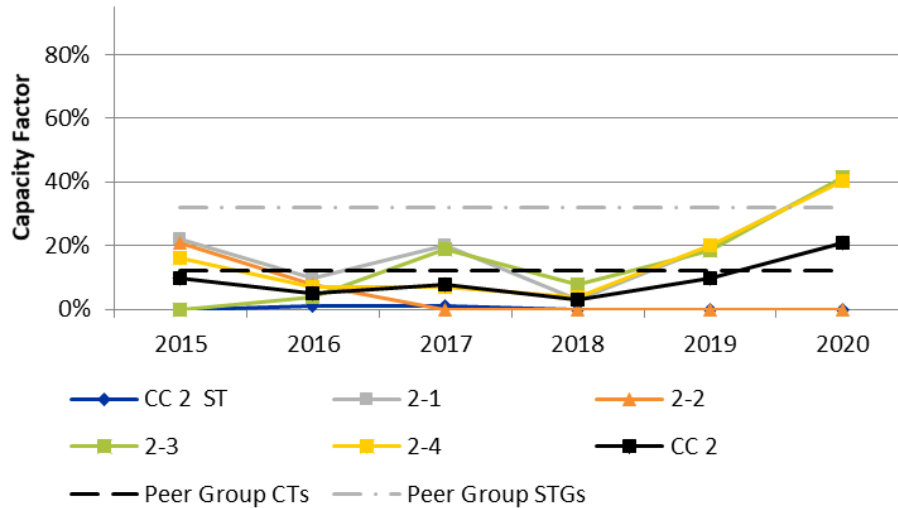
Figure 6-14 — Aguirre CC Unit 2 Capacity Factor

The NCF on STAG 2 is shown in Figure 6-14. In 2017, the STG came offline for high bearing vibration, and in 2018 the condenser waterboxes were refurbished. The effect of these outages on the capacity factor is seen below and in the following plots for EAF and EFOR. The plots also indicate there were STG-related issues in 2015, but the Plant staff was unable to provide information for review. As explained above for the STAG 1 STG, hurricane damage caused limited CC operation in 2017 and 2018. The GTs were available

for simple-cycle operation. GT 2-2 remains out of service from a rebuild beginning in 2016. The average NCF depicts a recovery from a low of 3% in 2018 to 21% in 2020, which is generally in line with similar units.
